Appendix B

Fiscal Year 2002 Operable Unit 4-13 Operations and Maintenance Inspection Photos

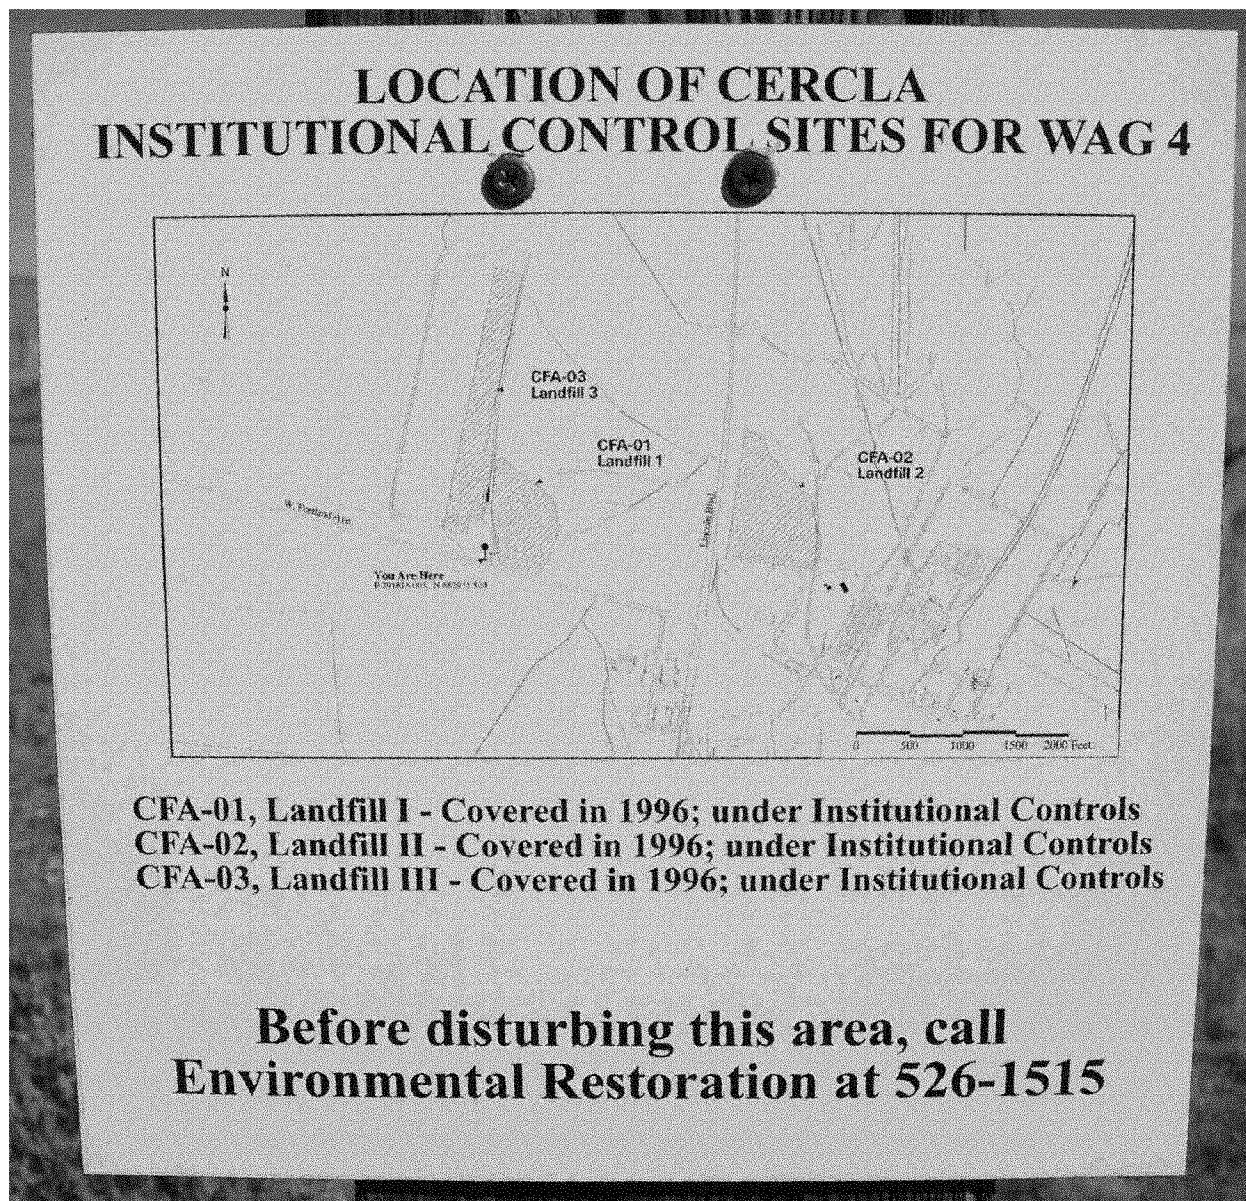
Figure B-1. CERCLA sign identifying locations of CFA-01, CFA-02 and CFA-03 (PD020605-35).

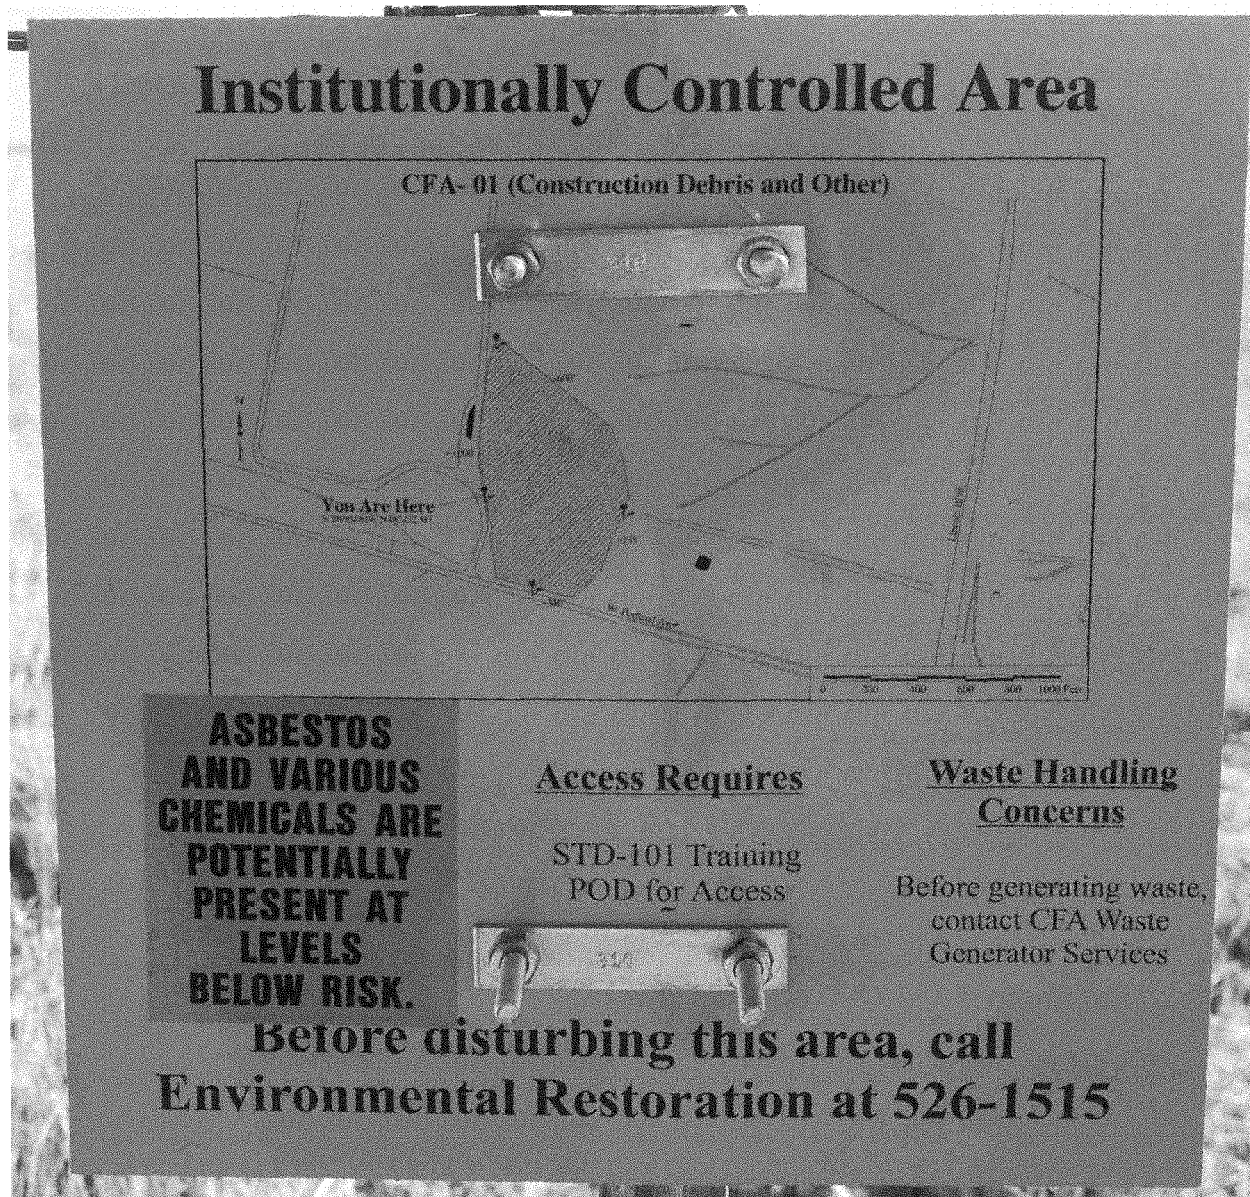
Figure B-2. Institutional control sign for CFA-01 Landfill I (PD020605-15).

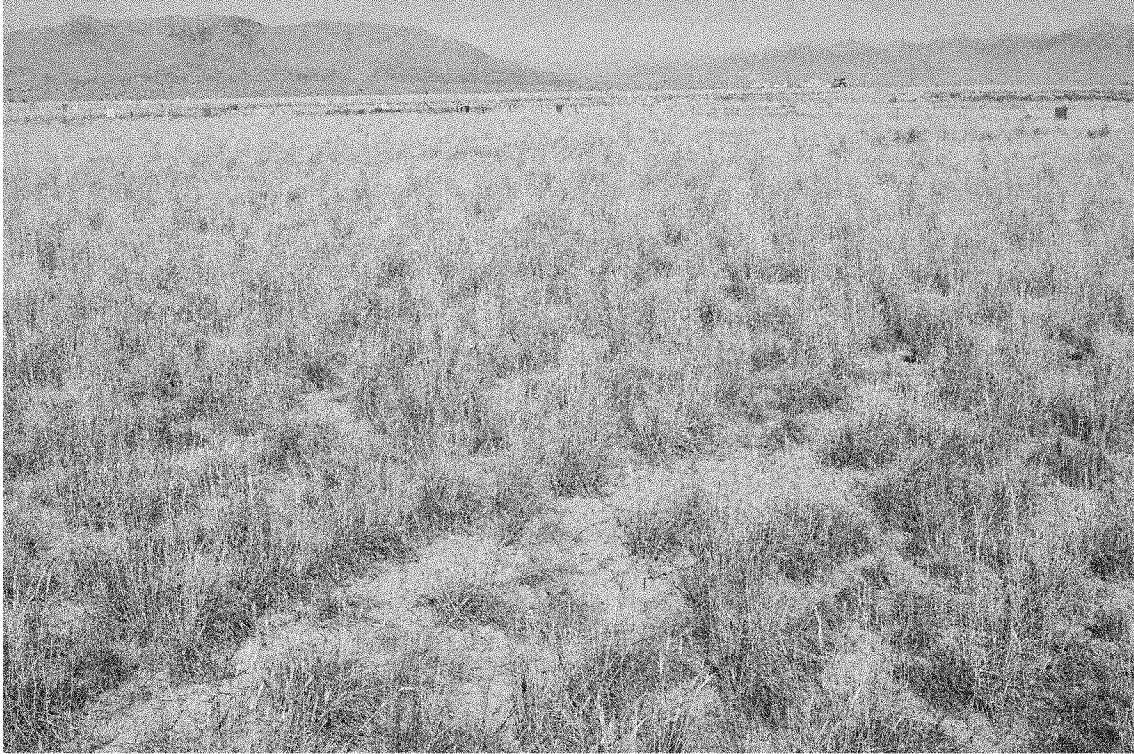
Figure B-3. View of CFA-01 Landfill I looking to the northwest (PD020605-16).

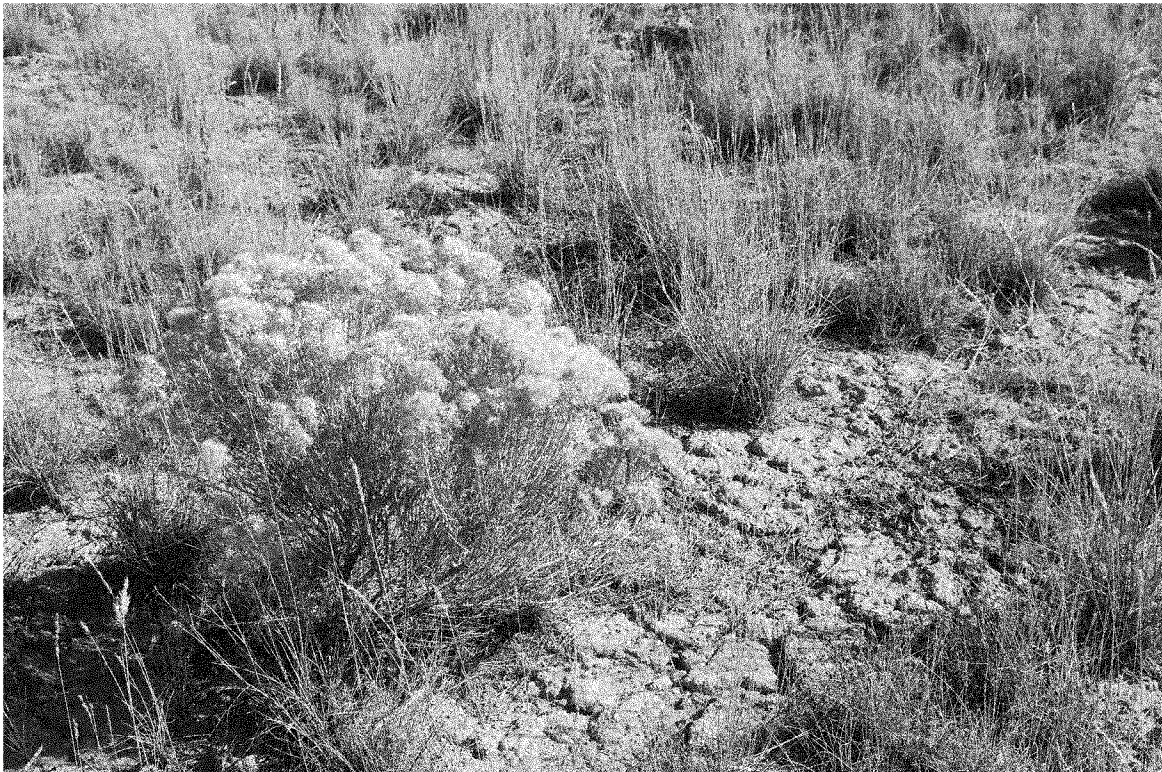
Figure B-4. Rabbit brush (typical) at the CFA-01 Landfill I (PD020605-19).

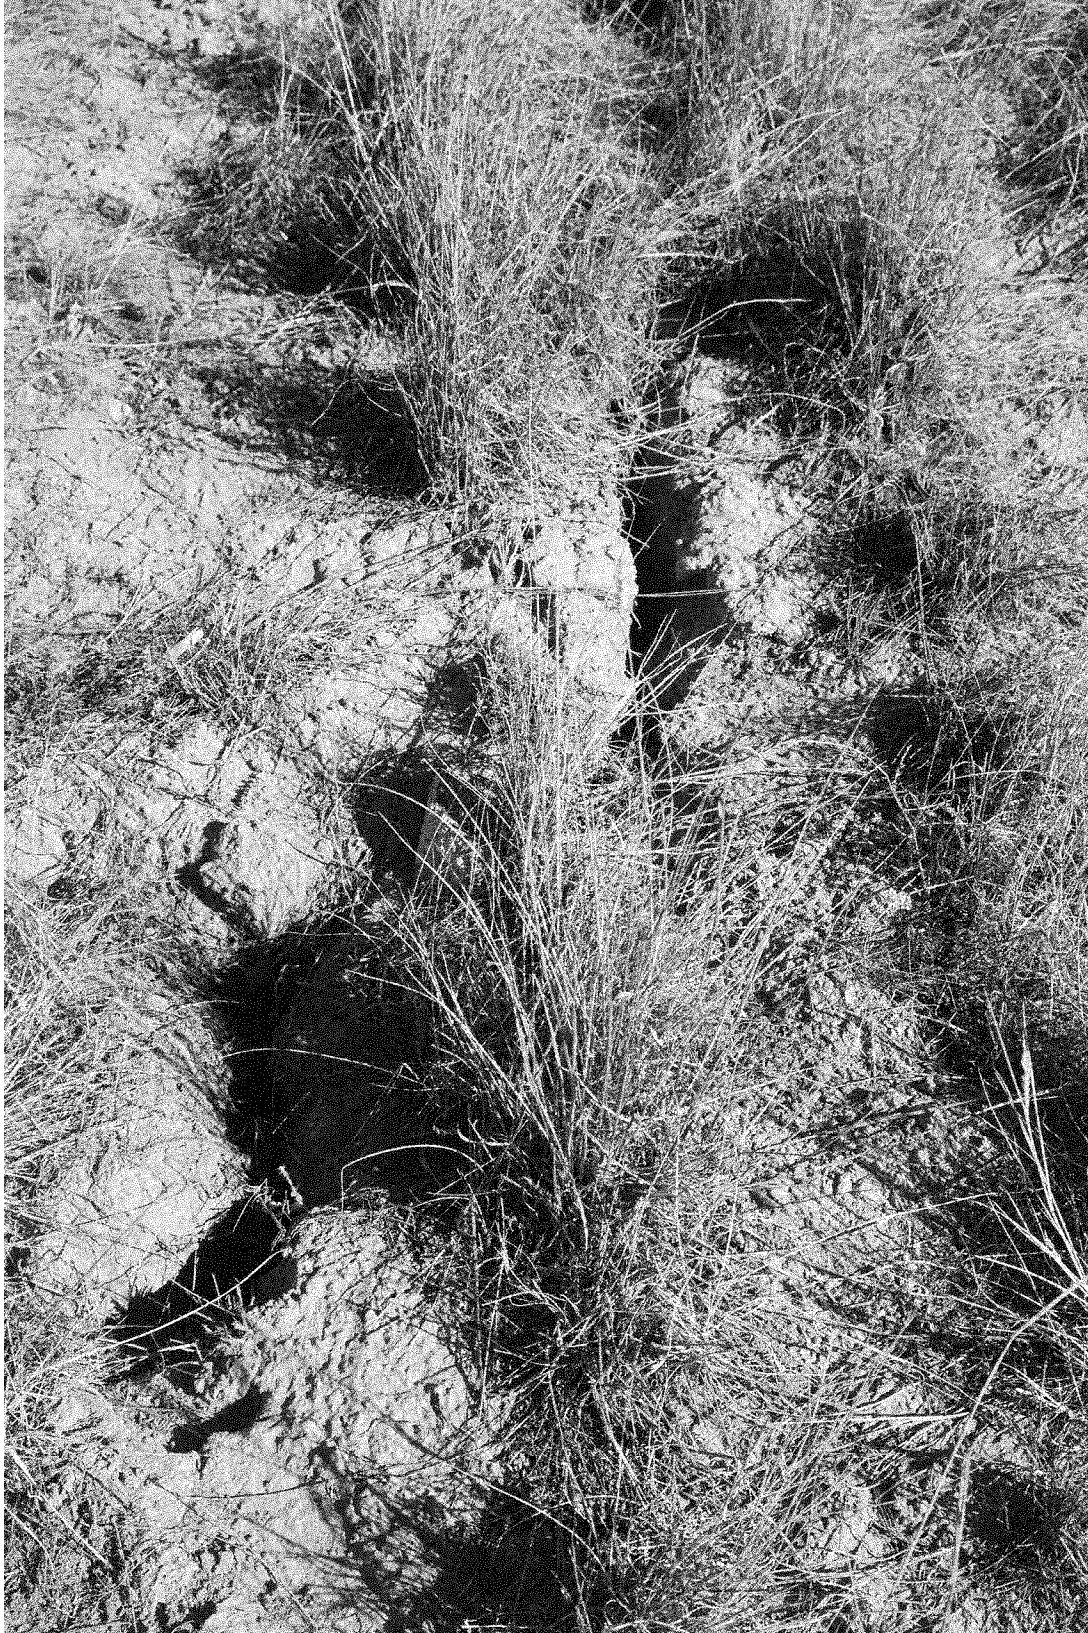
Figure B-5. Erosion rill at CFA-01 Landfill I (PD020605-20).
